Monitoring substrate and interstitial quality of the River Our, Luxembourg

Study carried as part of EU-Project LIFE05Nat/L/000116
« *Restauration des populations des moules perlières en
Ardennes* »

August 2011

Ian Killeen

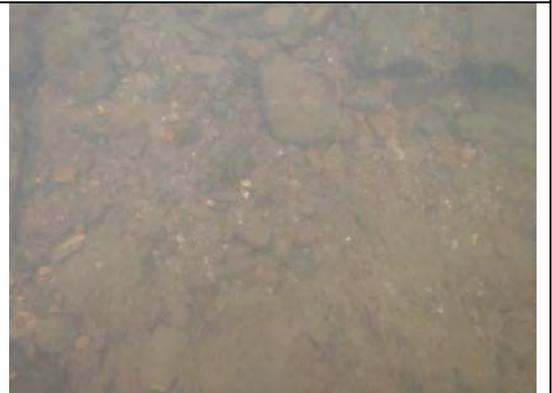
Mixed silty substrate

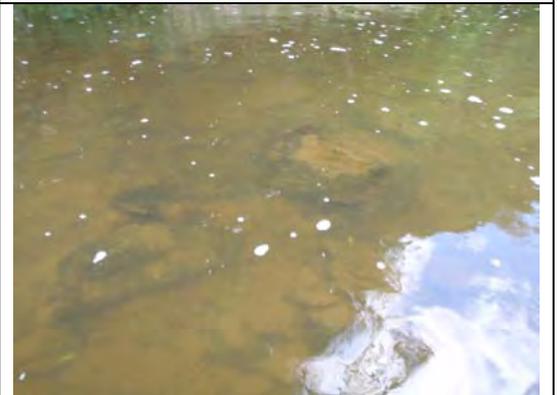
Coarse, silt-covered substrate

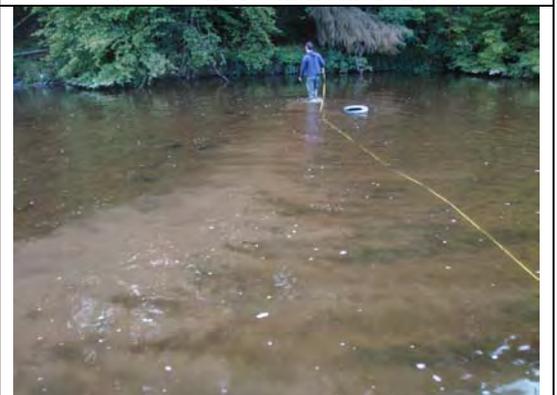
Muddy plumes

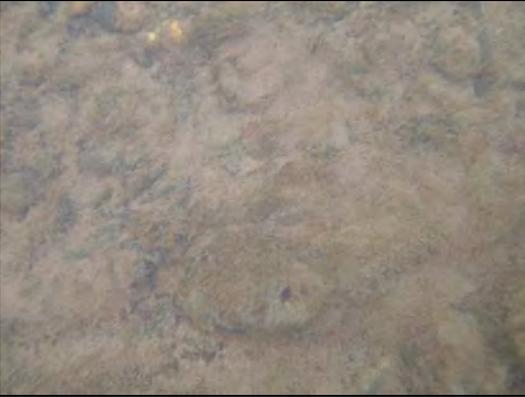
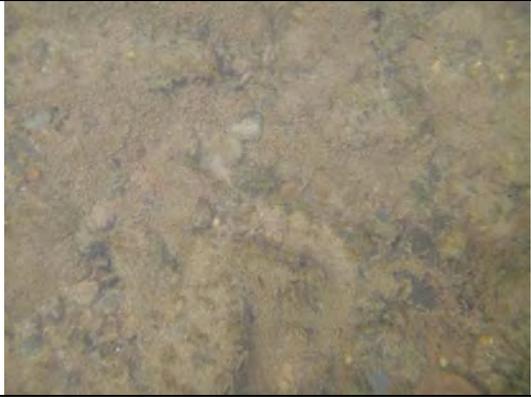
Substrate with silt, diatoms and dead algal flock	Substrate with silt, diatoms and dead algal flock

The highly silted nature of the substrate is clearly reflected in the redox potential measurements. The overall loss in redox at 5cm depth was 35.8% with very little significant difference across the channel. The more frequent areas of finer sediment allowed more readings (25) to be taken at 10cm depth, but the loss of redox was 48% showing high silt infiltration of the substrate to this depth.

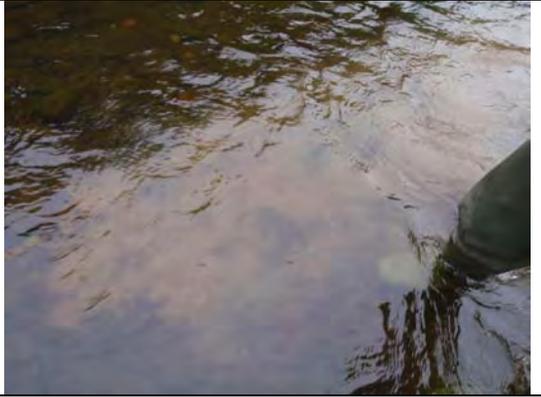
Angular cobble substrate at c.4m from R bank	Silt plumes from substrate

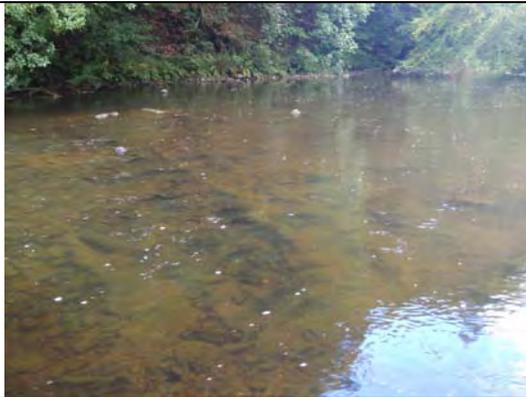
Silt-covered bedrock ledges across most of channel

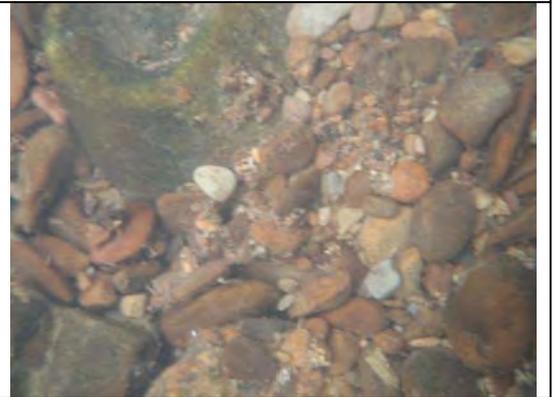
Clean (scoured) gravels amongst cobble along Left bank

The relatively low loss in redox potential at 5cm depth (24.7-27.1%) along the Left part of the channel reflects the rather unstable scoured nature of the substrate such that it is not as highly infiltrated with silt as the Right part of the channel where the substrate is more stable, and the losses in redox are much higher (33.3-42%). The layer of gravel component was very thin throughout the transect and therefore it was not possible to obtain any redox measurements at a depth of 10cm.

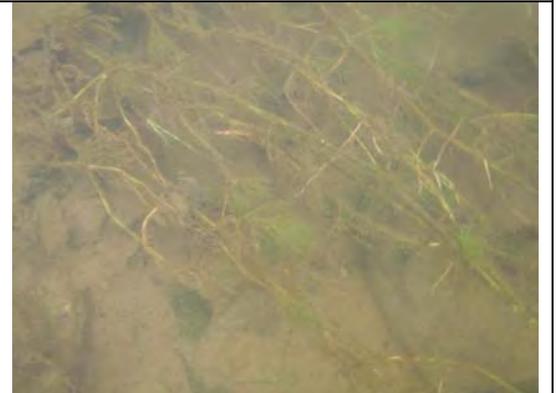
Silt covered cobble with sparse *Ranunculus*

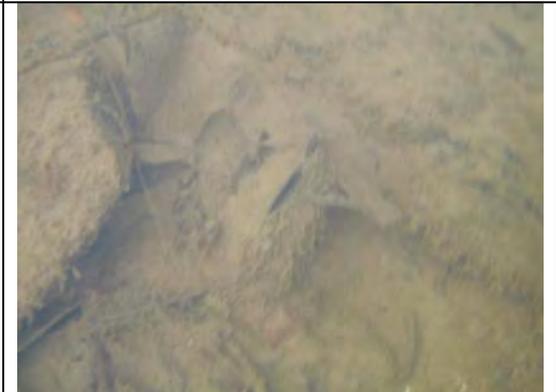
Mussel covered in silt

In the sample locations along the Left bank (in the run where the mussels were living) the levels of siltation within the substrate were very high with losses in redox potential at 5m depth ranging from 34.3-40.7%. The losses in mid channel and towards the Right bank were lower (29.1 -31.8%) but still high showing the substrate to be infiltrated by silt. No measurements were taken at a depth of 10cm.

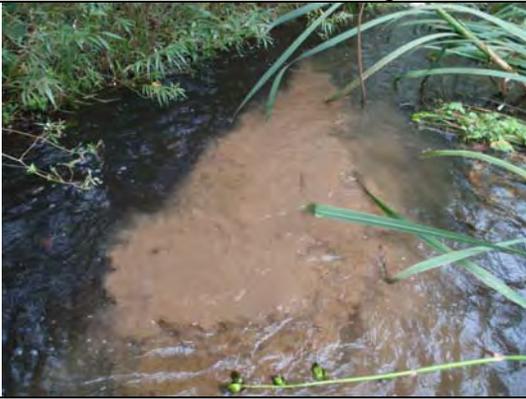
Silt plumes
